HOME INSPECTION REPORT

1234 Anywhere St.
Rockwall, TX. 75087

Inspection Date:
4/28/09

Prepared By:
A-Pro Home Inspection Services
Rockwall, TX. 75087
(972) 814-3845
Ron.Faraci@aproweb.com

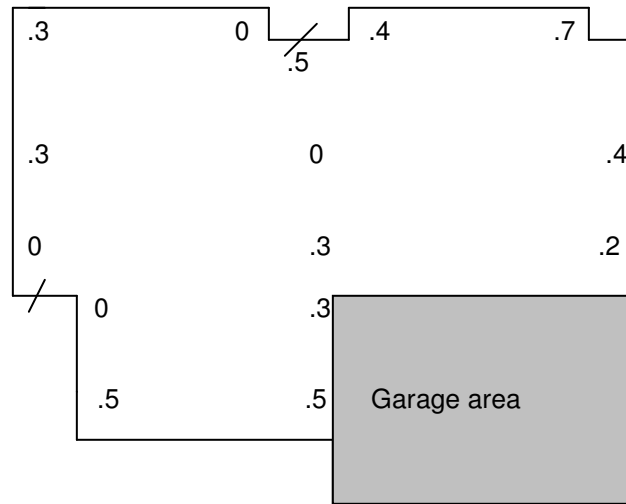
FOUNDATION LEVEL SURVEY

A foundation elevation differential of .7 inches was recorded on the main structure (refer to the Elevation Survey).

This is considered well within the normal limits. No major defects were observed in the accessible structural components of the house. The building exhibits no evidence of substantial structural movement.

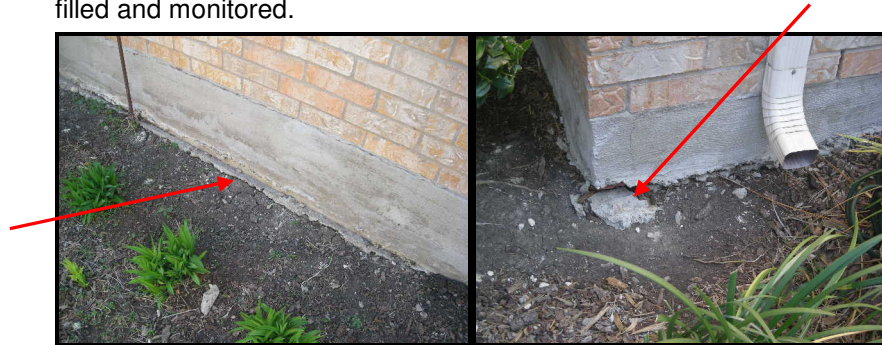
Evidence of minor soil subsidence was noted at the foundation perimeters. Soil subsidence may lead to possible foundation settlement; these areas should be filled and monitored.

- Evidence of minor soil subsidence was noted at the foundation perimeters. Soil subsidence may lead to possible foundation settlement; these areas should be filled and monitored.
- There is evidence of a water leak from the dishwasher. It is not leaking at this time, but this should be monitored.

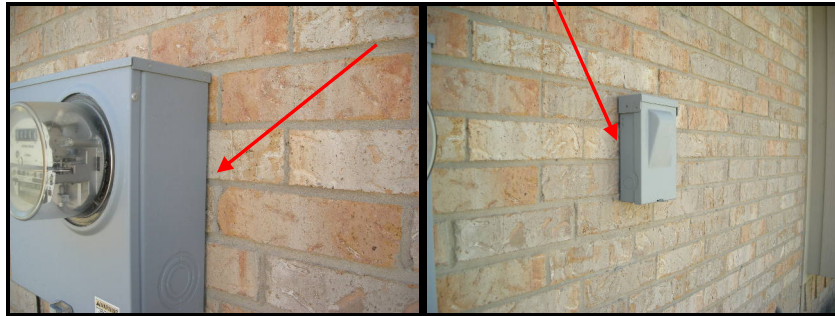
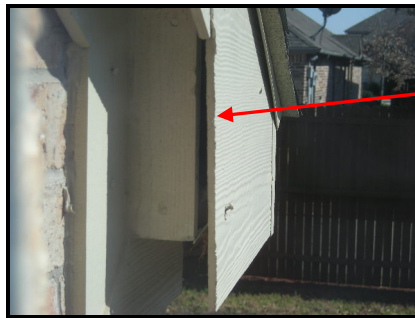
Make sure all openings in outside wall are sealed. There is evidence of a bird nest behind wood next to chimney

Sealing the openings in the exterior veneer and around all electrical panels and disconnects is recommended as needed.

- Sealing the openings in the exterior veneer and around all electrical panels and disconnects is recommended as needed.
- Make sure all openings in outside wall are sealed. There is evidence of a bird nest behind wood next to chimney.

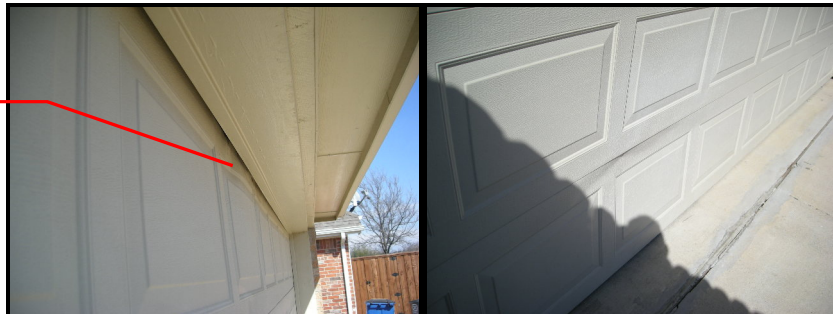
The overhead garage door is damaged and needs repair.

The door is bent and does not close properly

- The overhead garage door is damaged and needs repair.

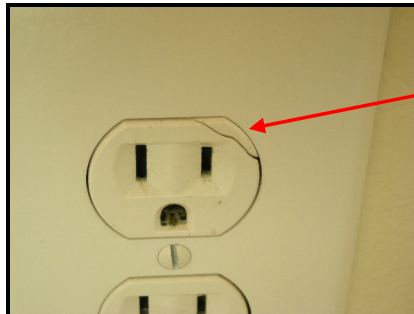
Broken outlet in hallway should be replaced.

- Broken outlet cover plates in the living room should be replaced.
- Broken outlet in hallway should be replaced.
- The lights are inoperative in the master bathroom over the tub. If the bulbs are not blown, the circuit should be investigated.

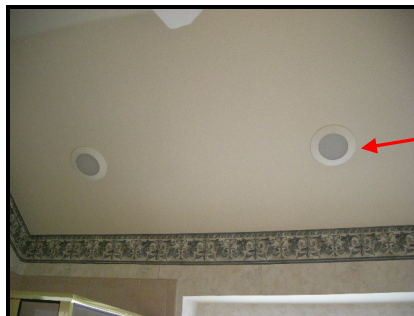
The lights are inoperative in the master bathroom over the tub. If the bulbs are not blown, the circuit should be investigated.

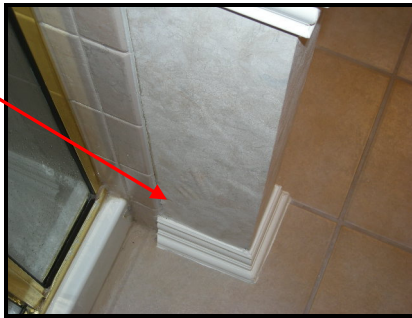
Wall outside of shower stall in master bath show signs of water damage.

- Cracked, deteriorated and/or missing bathtub enclosure grout and caulk should be replaced in the front bathroom.
- Wall outside of shower stall in master bath show signs of water damage.

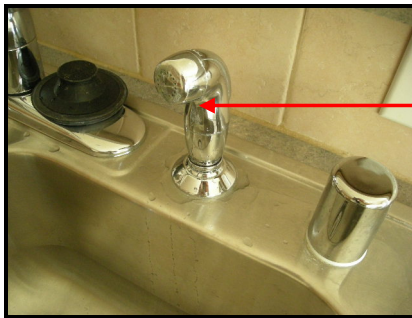
The vegetable sprayer on the kitchen sink leaks when the water is turned on.

- The bathtub was observed to drain very slowly in the master bathroom, suggesting that an obstruction may exist.
- The vegetable sprayer on the kitchen sink leaks when the water is turned on.

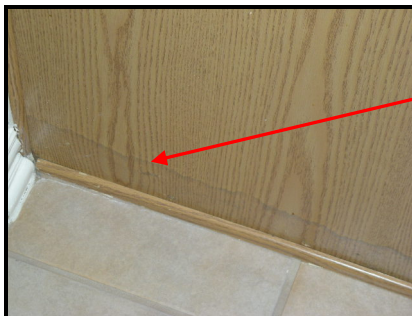
There is evidence of a water leak from the dishwasher. It is not leaking at this time, but this should be monitored.

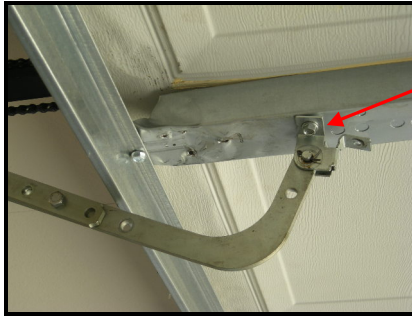
The arm between the garage door opener and the door is loose and should be properly secured.

- The water heater burner is dirty. It should be cleaned and adjusted.
- The arm between the garage door opener and the door is loose and should be properly secured.

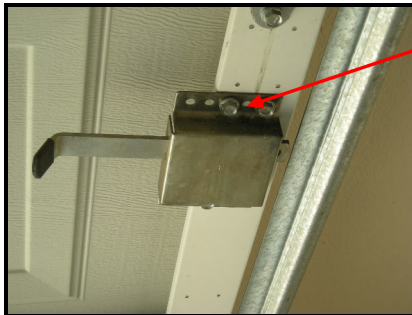
The manual lock on the garage door should be disabled. This is recommended when using a garage door opener.

- The manual lock on garage door was found to not be disabled. This is recommended when using a garage door opener.
- The door bell was inoperative and should be repaired.

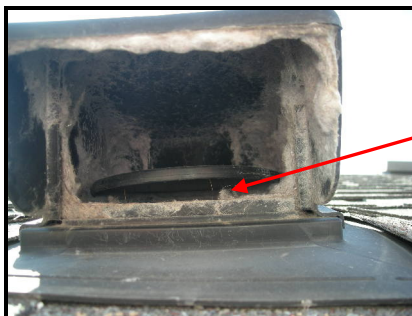
The dryer vent flap was open at the time of inspection. Improvements are recommended to allow for the flap to be in the fully closed position when the dryer is not in use.

- The dryer vent flap was open at the time of inspection. Improvements are recommended to allow for the flap to be in the fully closed position when the dryer is not in use.
